TS-PIC- 90900
February 1991

EPA Site Analysis
Chemsol Site
Piscataway, New Jersey

Site Analysis
Chemsol Site
Piscataway, New Jersey

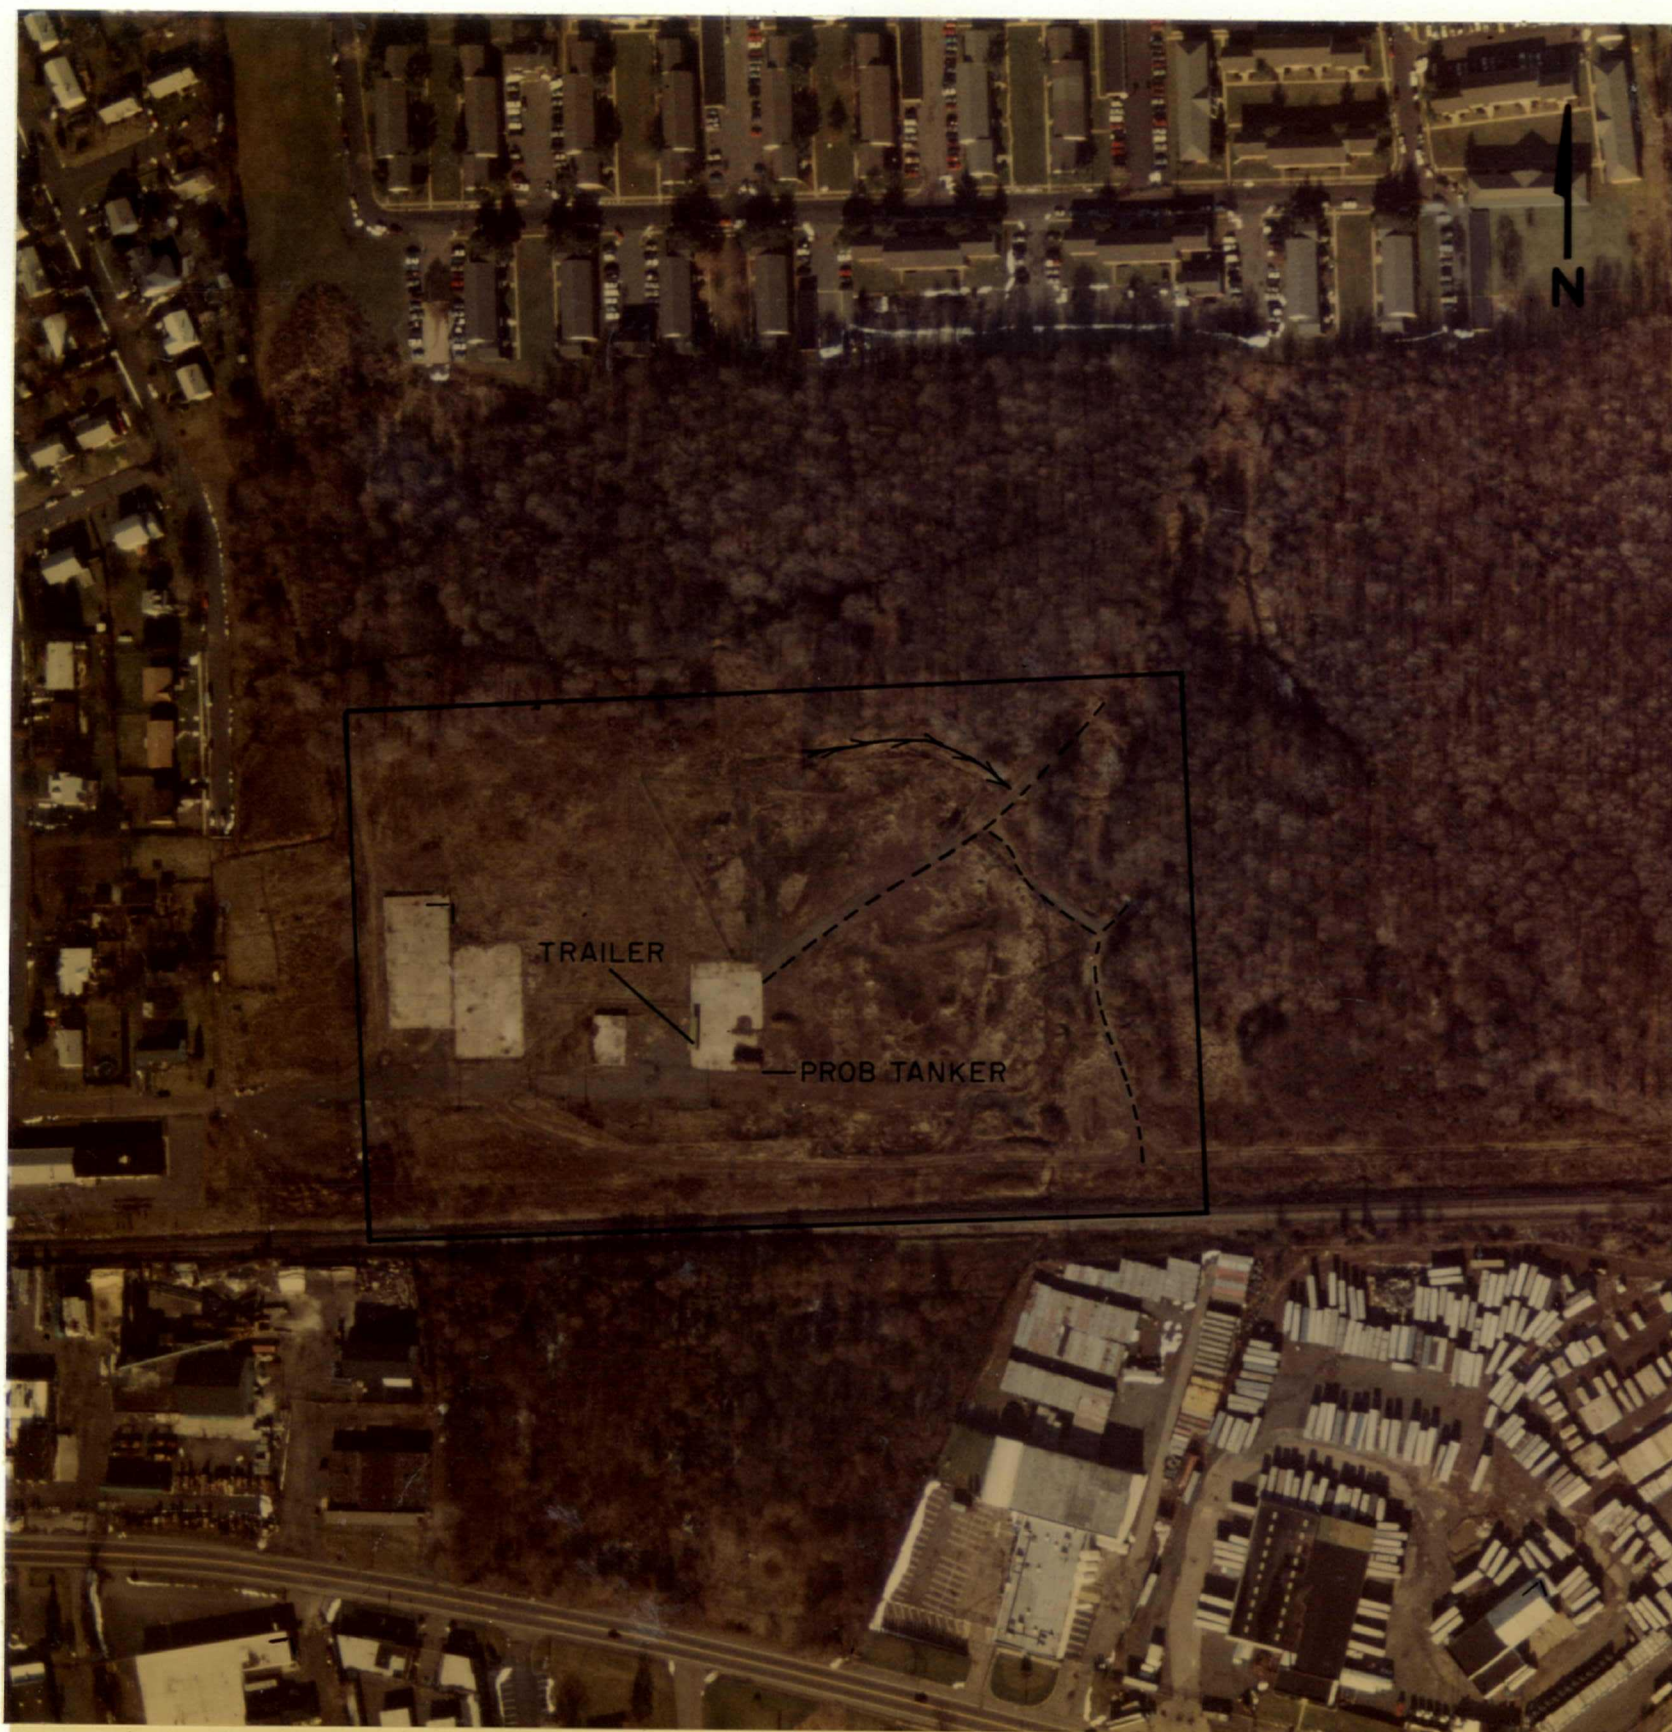
FIGURE 8
CHEMSOL SITE

The drum storage area* appears to be revegetating. The drainage channel running parallel to the southern boundary of the site has been filled.

A possible shallow depression remains at the former impoundment* (not annotated). A road has been constructed that runs from the center of the site towards the northeastern boundary of the site. One branch of this road runs south past the former impoundment.*

All mounds of light- and medium-toned material have been removed, and the one remaining building has been razed. A trailer and probable tanker are parked on the foundation of one of the razed buildings.
